A Geotechnical and Geochemical Characterisation of Oil Fire Contaminated Soils in Kuwait

Humoud Al-Dahani¹, Paul Watson¹ and David Giles², ¹School of Civil Engineering and Surveying, ²School of Earth and Environmental Sciences, University of Portsmouth, UK.

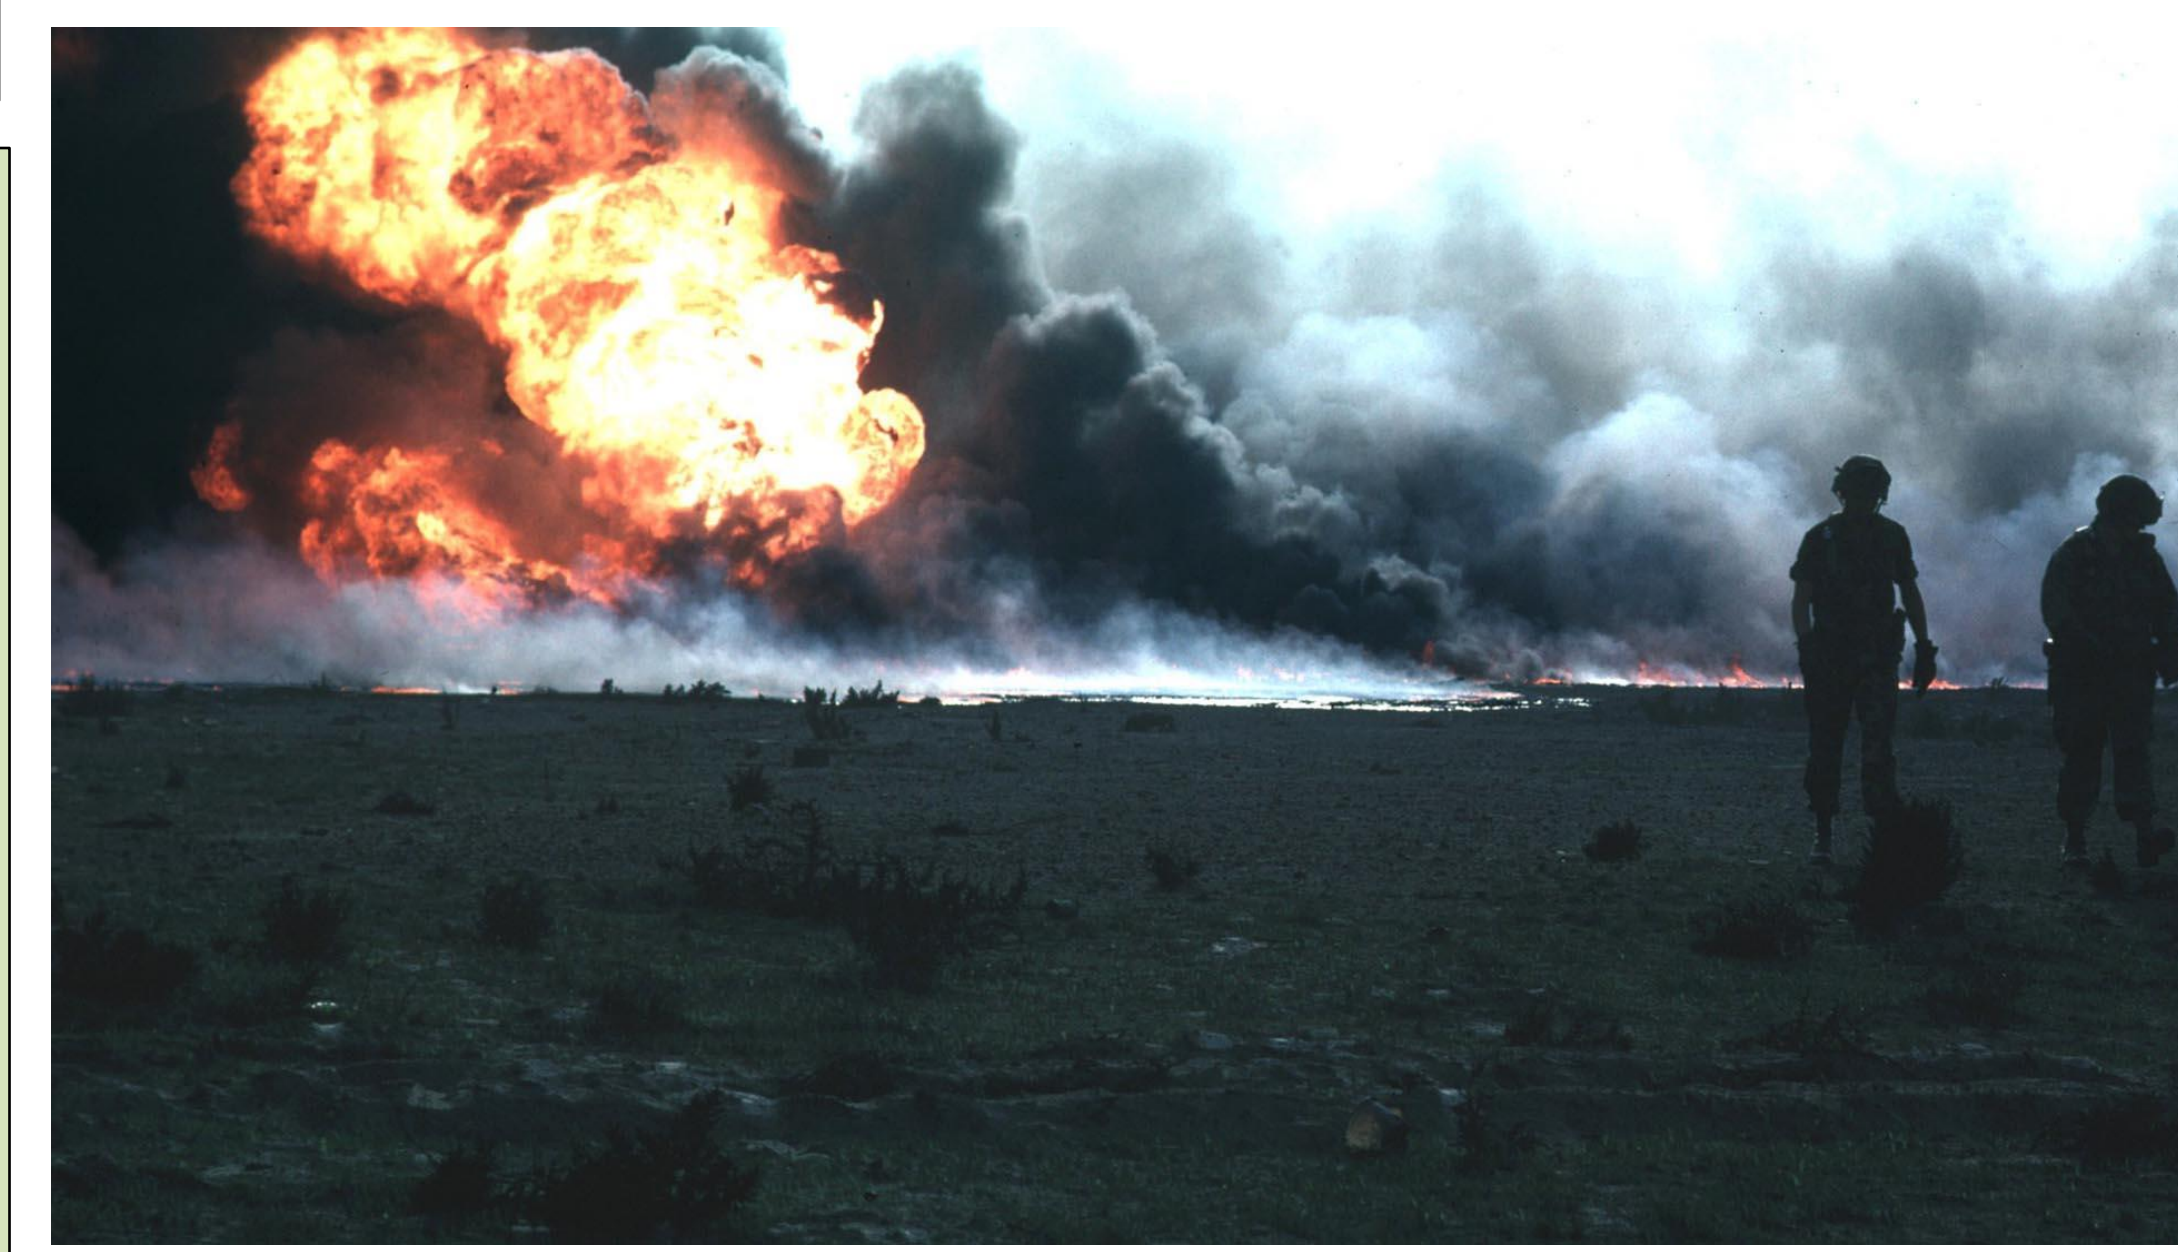
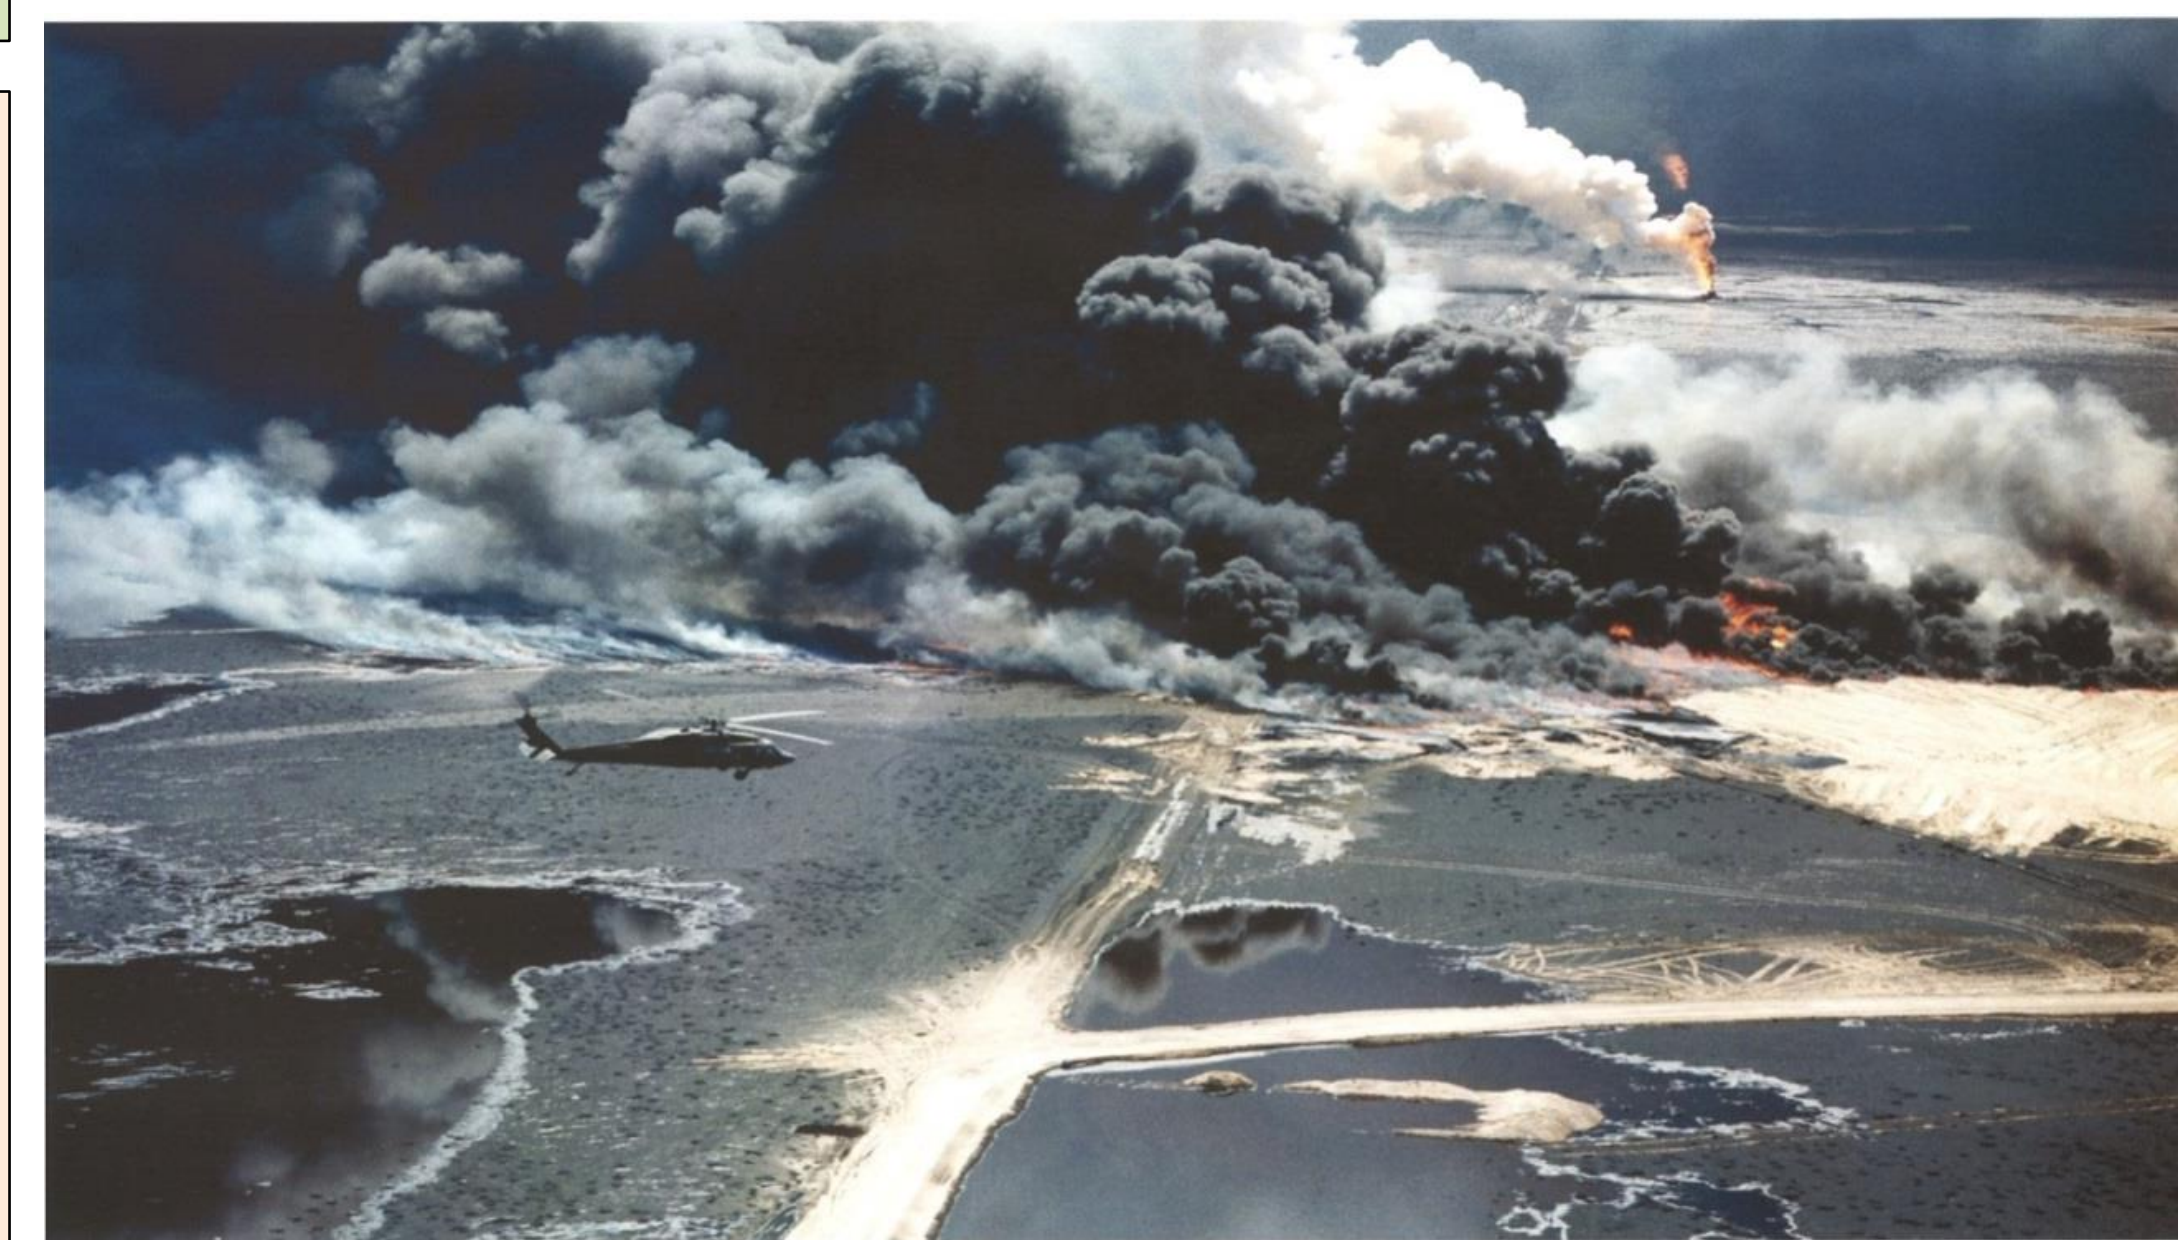
Fig 2. Burning oilfields during Operation Desert Storm, Kuwait. Environmental damage caused by the fires & oil lakes have had a lasting impact on Kuwait's ecosystem (USACE, KOC).

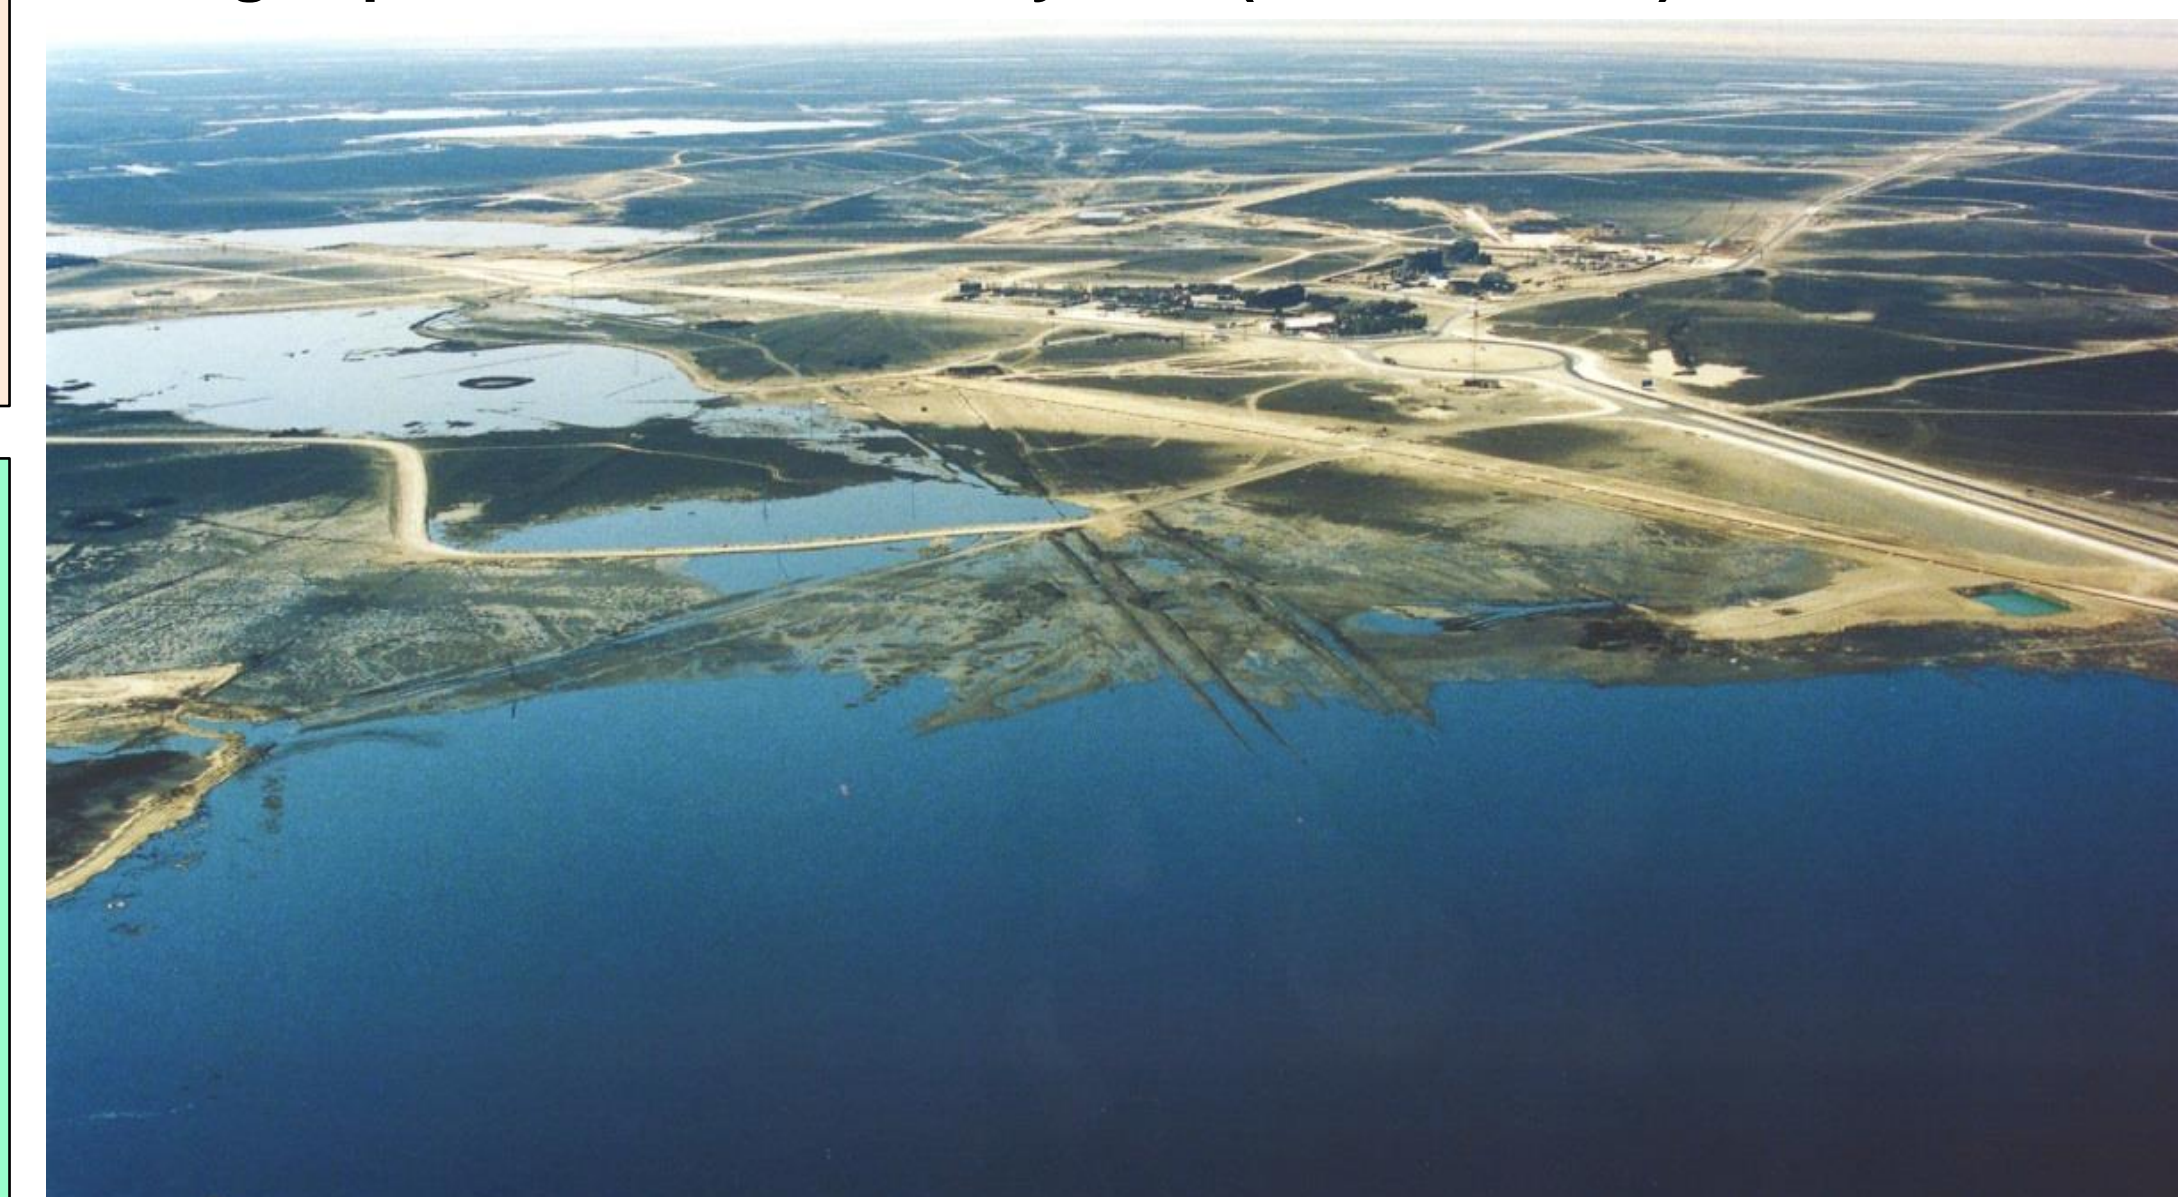
Fig 3. Aerial view of the oil lakes that formed as a result of the damage inflicted by retreating forces. (KOC).

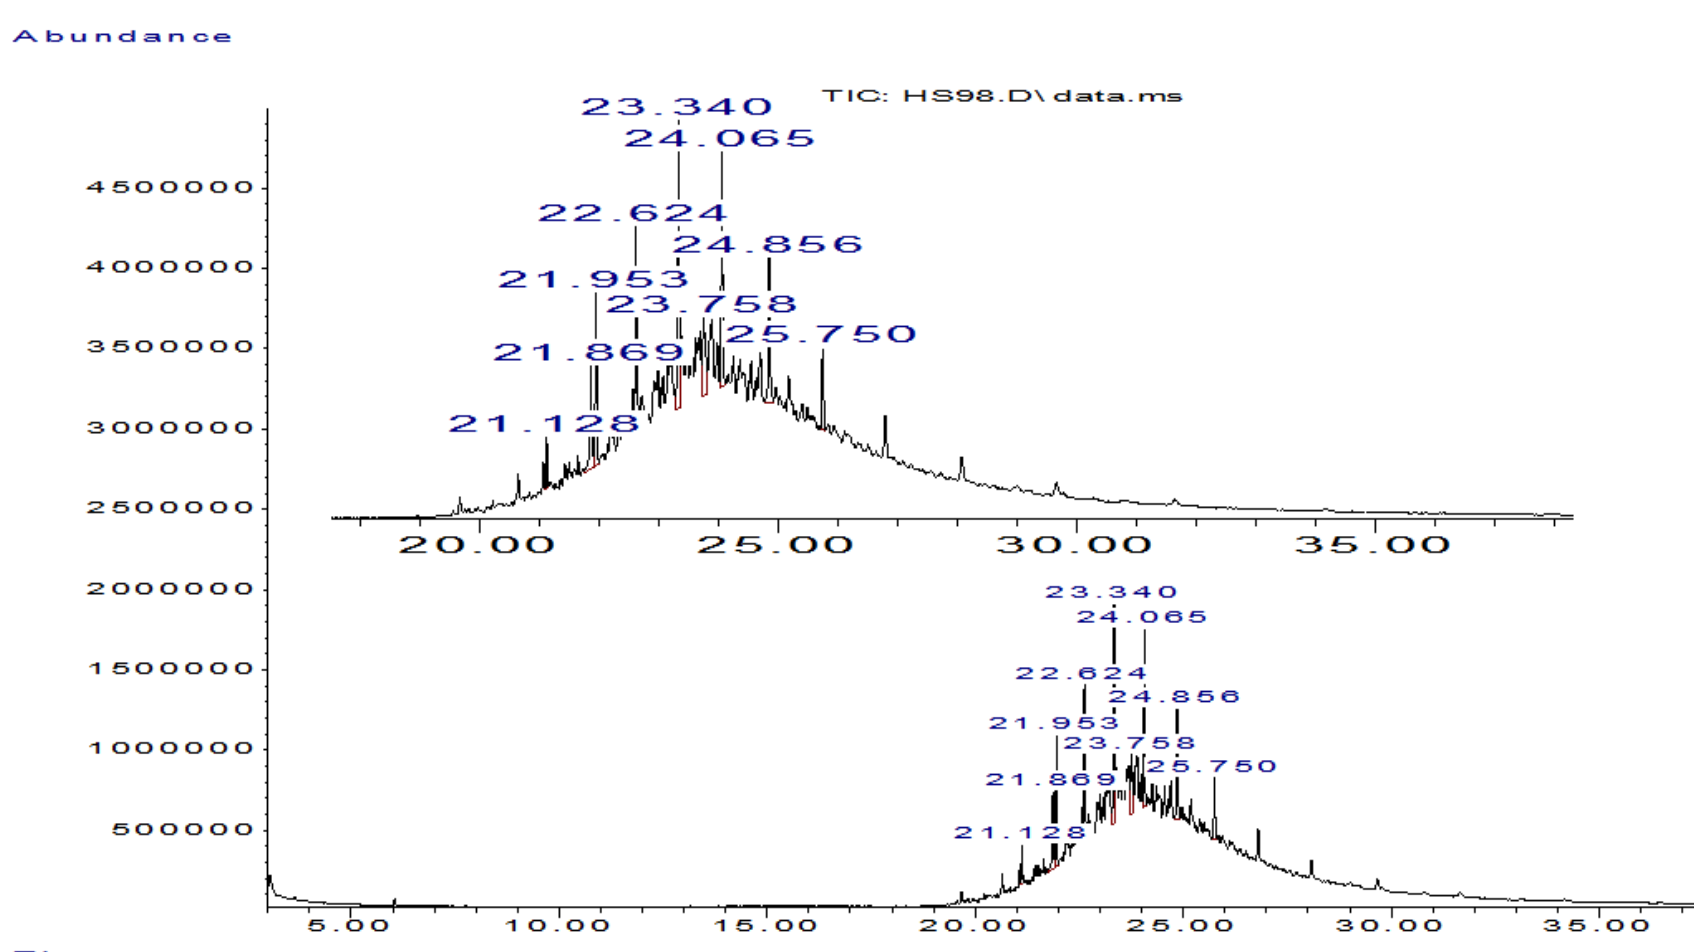
Fig 4. Chromatogram showing hydrocarbon contamination in the detected soil sample with Total Petroleum Hydrocarbons at depth 0m (ground surface), at a contaminated site in the Al-Magwa area.

- Chemical testing primarily used Gas Chromatograph Mass Spectrometry (GCMS) to ascertain the nature of the residual hydrocarbons present together with elemental analysis

- Water soluble chlorides, sulphates & pH levels were tested
- GCMS enabled speciation of hydrocarbons present in order to determine the degradation that had taken place since the original spillages in 1991

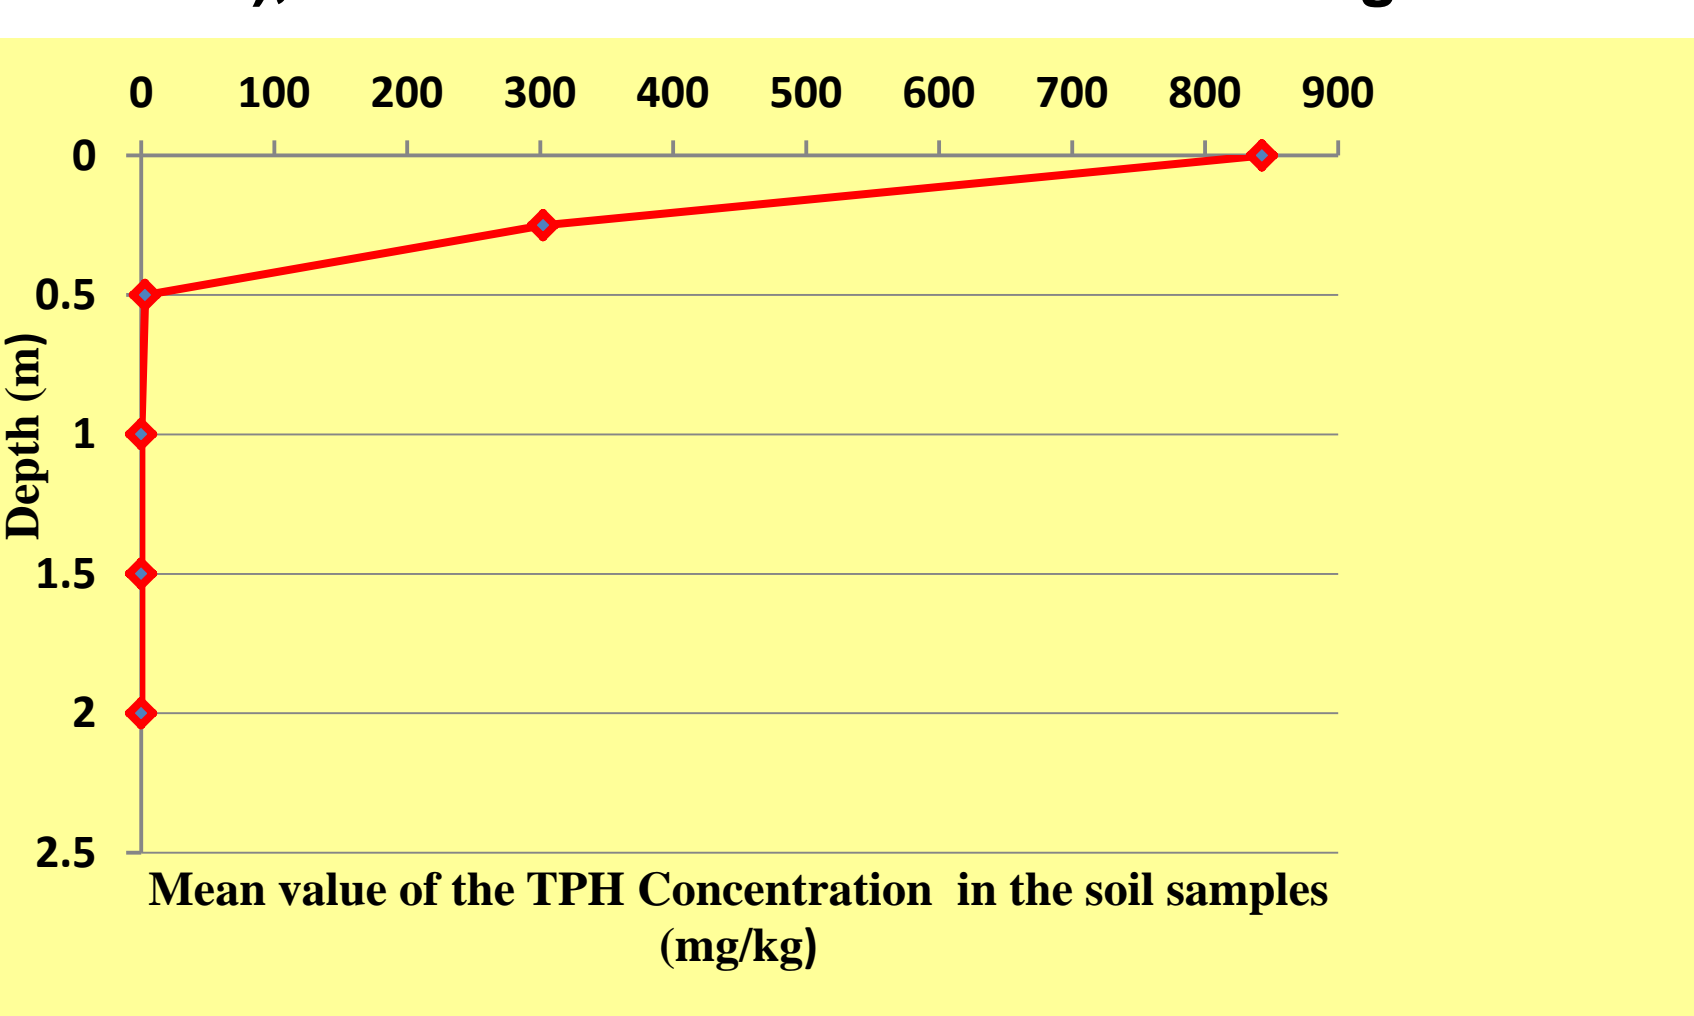
Fig 5. Mean value of the TPH concentration (mg/kg) in soil samples at depths 0.0m, 0.25m, 0.5m, 1.0m, 1.5m & 2.0m, Al-Magwa area.

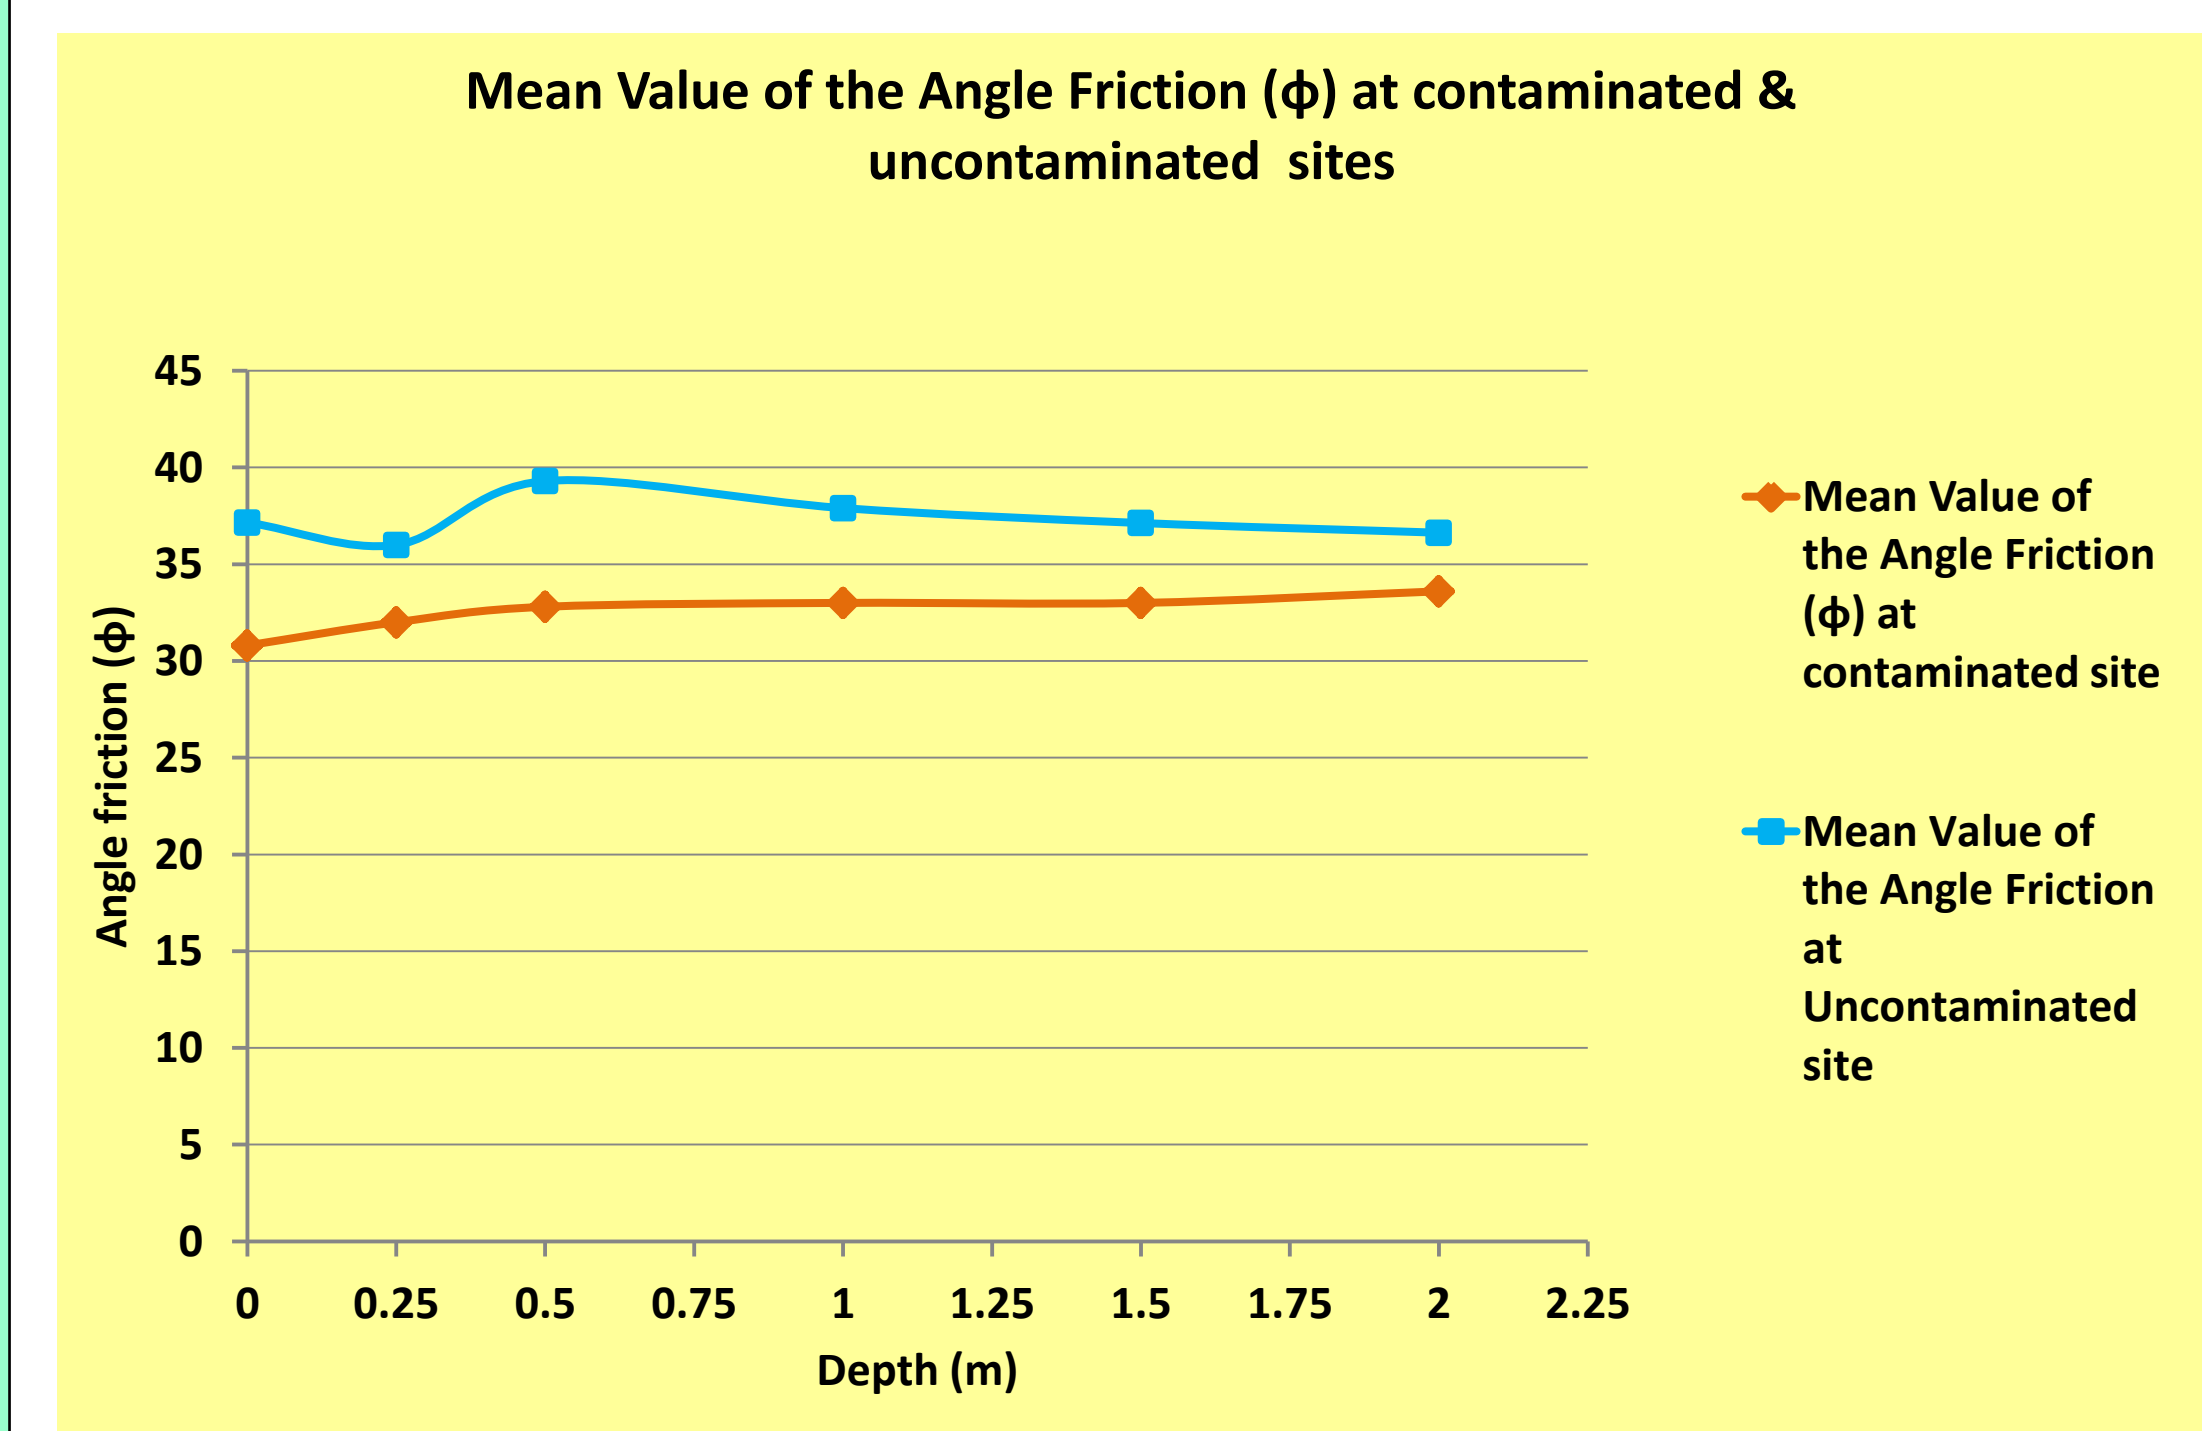
Fig 6 Comparison of the Mean Values of the Friction Angle (φ) from direct shear tests for soil samples at depths 0m, 0.25m, 0.5m, 1.0m, 1.5m & 2.0m at contaminated and uncontaminated sites in the Al-Magwa area.

- Laboratory geotechnical tests were undertaken including Atterberg Limits, PSD analysis, permeability analysis & direct shear tests (where appropriate)
